# The Lost Walls of the Lower Wye Valley

A Report on the Drystone Walls of the Wye Valley Area of Outstanding Natural Beauty

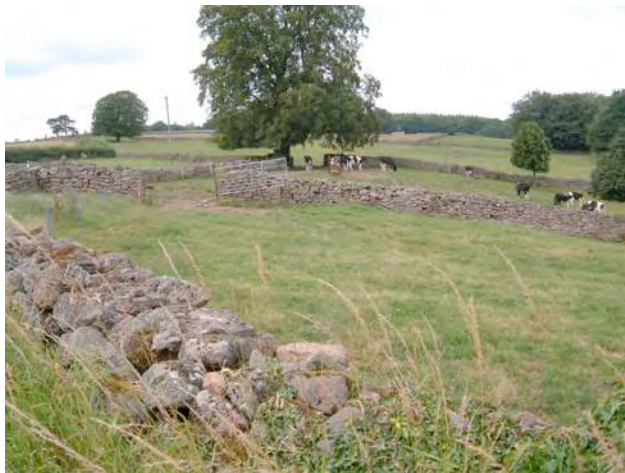
It is possible that some of the walls in the Wye Valley are much older than those associated with the enclosure acts. Walls near Ninewells Farm, Catbrook are, by local reputation, associated with the monastic activities at Tintern Abbey which would date them back to the 1500's.

*Drystone Walls at Ninewells, Catbrook*

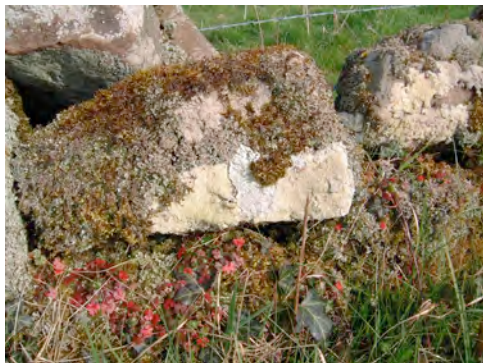
*Lichen covered stones*

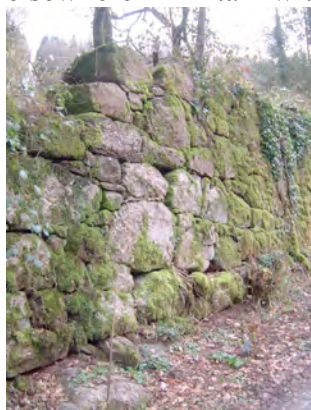
The size of stone varies, ranging from blocks manageable with one hand to blocks so large that nowadays they would require a machine to lift them. The largest of these stones must originally have been placed with block and tackle or the use of heavy horse and ropes. The large size of the stones and the frequency of their use within a small area is not seen elsewhere in Britain with the possible exception of North Wales.

*A drystone wall in Manor Brook showing the large stone sizes used.*

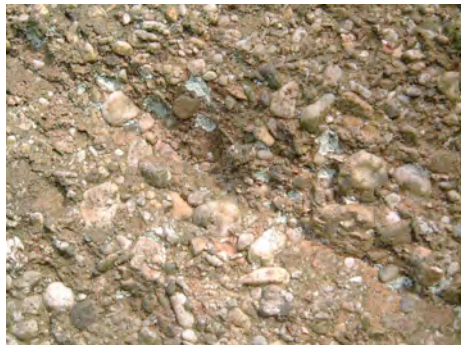
Less frequently used, quartz conglomerate consists of a sandstone matrix containing quartz pebbles. This appearance gives rise to the local name of pudding stone and in some places jack stone. The stones are often awkwardly shaped for walling purposes a problem which is exacerbated by the fact that the stone is difficult to dress and will frequently shatter when tapped with a hammer.

*Pudding stone*

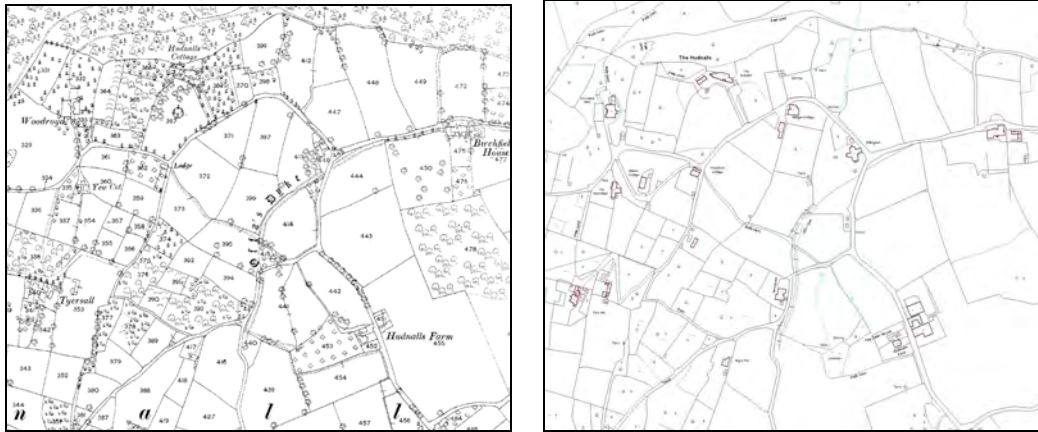
*Map of a section of the 1885 map from near St Briavels alongside a current map for comparison .*

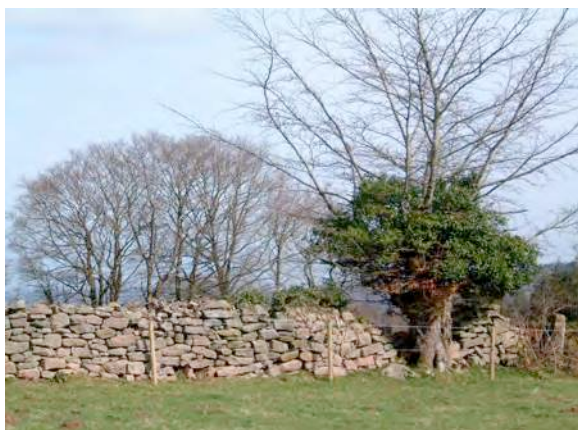
- Incorrect building techniques, e.g. placing the larger stones near the top of the wall and smaller stones near the base
- Animals such as rabbits and badgers burrowing underneath
- Trees growing in or adjacent to the wall
- Livestock climbing, leaning and rubbing against the wall
- Human activity such as climbing over walls, hitting walls with vehicles and machinery, theft of stone and removal of stone for other purposes

*Wall damage caused by a tree*
